**PHASE I ENVIRONMENTAL SITE ASSESSMENT  
NORTHEAST OF INTERSTATE 101 AND COCHRANE ROAD  
MORGAN HILL, SANTA CLARA COUNTY, CALIFORNIA**

**Browman Development Company**  
100 Swan Way, Suite 206  
Oakland, California 94621

**The Twining Laboratories, Inc.**  
2527 Fresno Street  
Fresno, California 93721

June 21, 2004

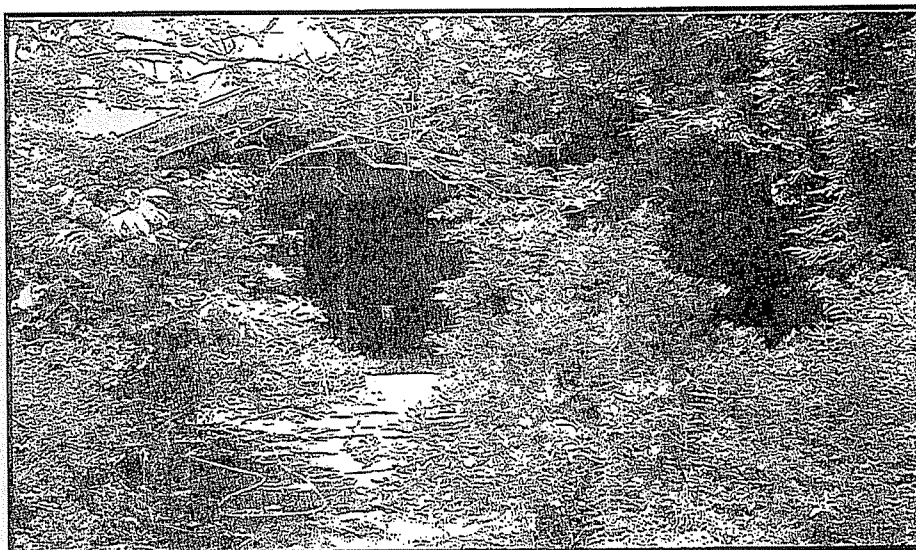
### PHOTOGRAPH 2

(Millerd-Low Property) Typical view of the residence located at the southeastern portion of the property.

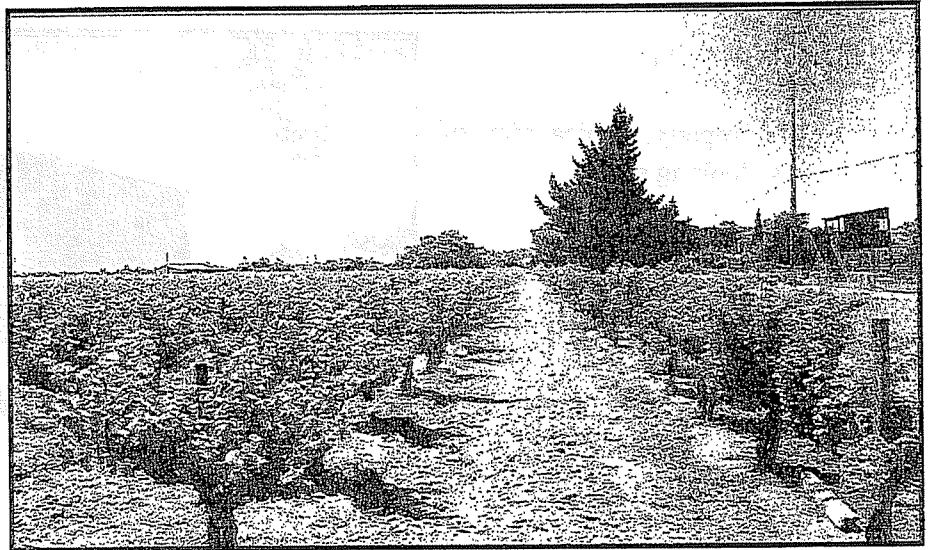
### PHOTOGRAPH 8

(Guglielmo Property) Typical view of the vineyard.

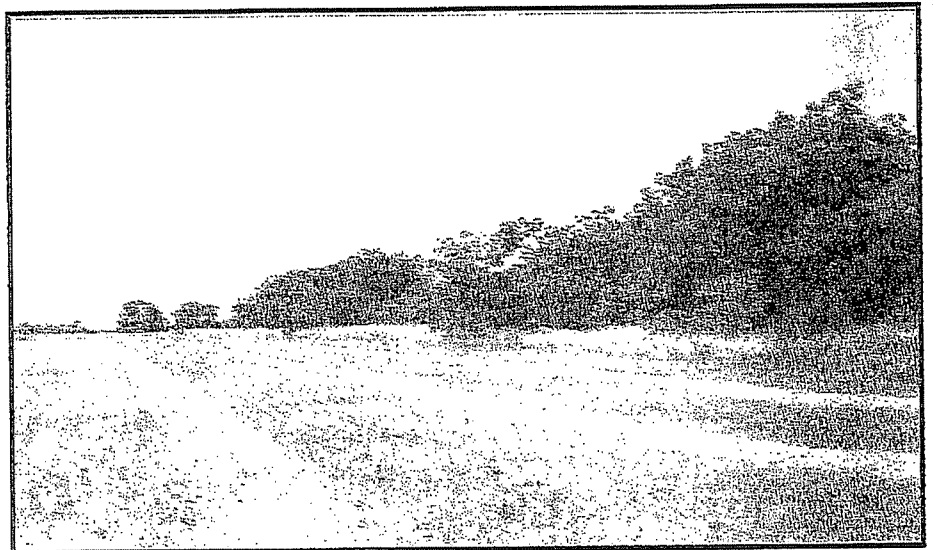
### PHOTOGRAPH 14

(Sullivan Property) Typical view of the property looking north from the southwestern portion of the Site

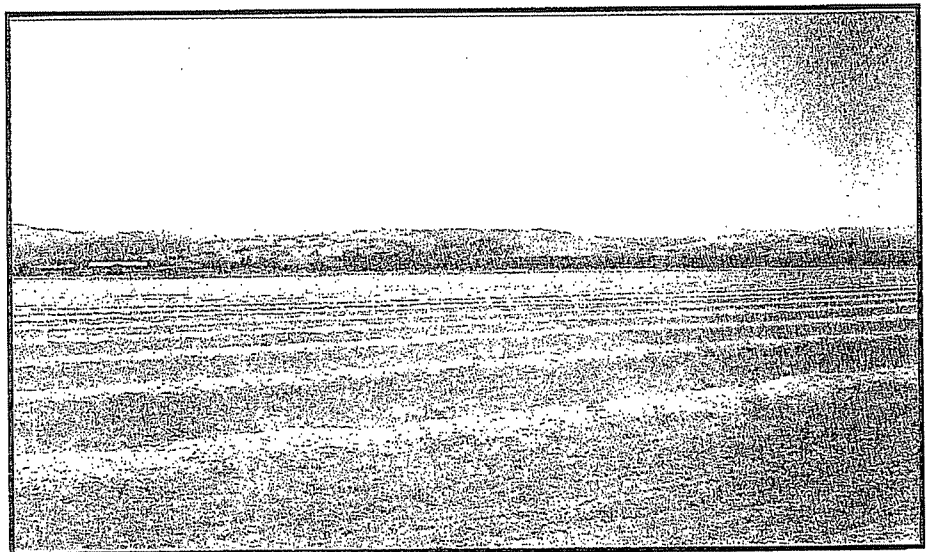
### PHOTOGRAPH 15

(Sullivan Property) Typical view of the property looking west from Cochrane Road.
